# Chama Coal Tipple Structure Report / Maintenance Plan

## Cumbres & Toltec Scenic Railroad

Prepared by Steven Kells and Jim Kreis  
for the Friends of the Cumbres & Toltec Scenic Railroad  
Winter, 2002

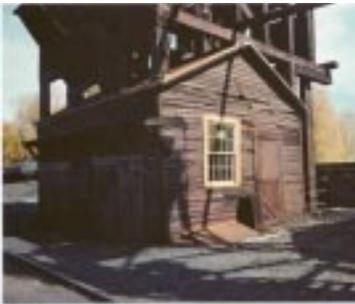
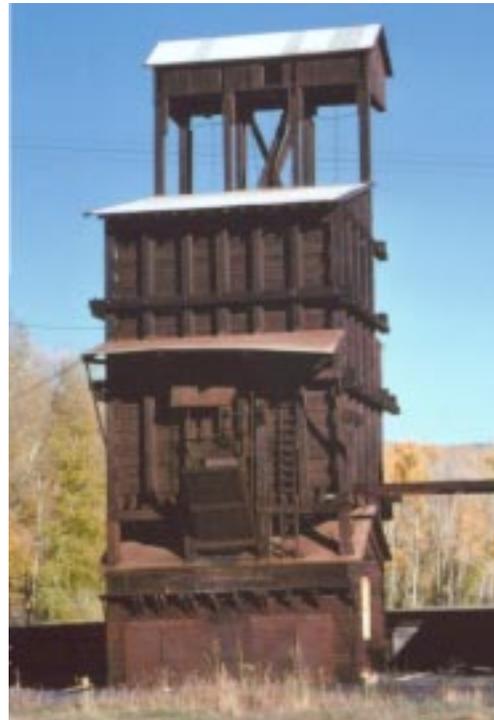
In 1979, the roofs of the coal pocket, sheave house, and possibly the hoist house were replaced. The cantilevered roof over the coal chute was not replaced. Photographs indicate that this work was accomplished without the use of scaffolding. At this time new windows were also installed.

*Figures 1&2  
1979 Repairs  
(Note New Roofs)*

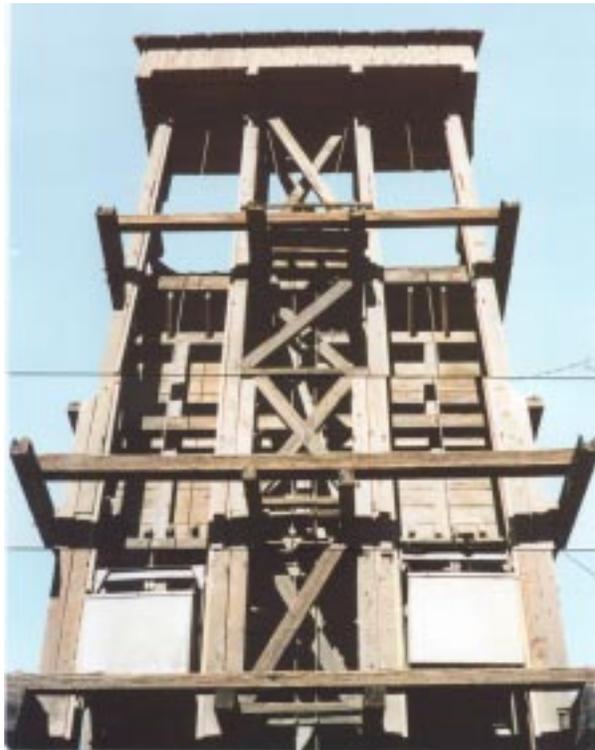
Figure 3 - East Side

Inspection of the tipple reveals that there are several deviations from the design drawings. Primary among these are the addition of diagonal X-brace timbers set between the two inner 8x18 bucket guide timbers.

Five pairs of these braces are set above each other from the hoist house level to the sheave house. They provide substantial north-south stability to the structure. Diagonal braces on the north-south axis, also not shown on the original drawings, are set inside the hoist house. It is not clear whether or not these braces were added at the time of construction or later, but there is reason to suspect that they were added later. The X-brace members set between the guide timbers demonstrate a generally lower level of workmanship than the rest of the structure, and at least one member was trimmed with an adz to fit (see fig. 4). One of the interior timbers has the imprint of a splint ring bolt connector on its side, suggesting that it too may have been a reused timber. Also the concrete footings do not extend under the bearing block for the interior braces, suggesting that they may not have been originally planned. A photograph of the Durango tipple in the 1958 *Narrow Gauge in the Rockies* by Beebe and Clegg shows that structure with only two or possibly three pairs of the braces between its guide timbers, further suggesting that they may also have been an ad hoc later addition.

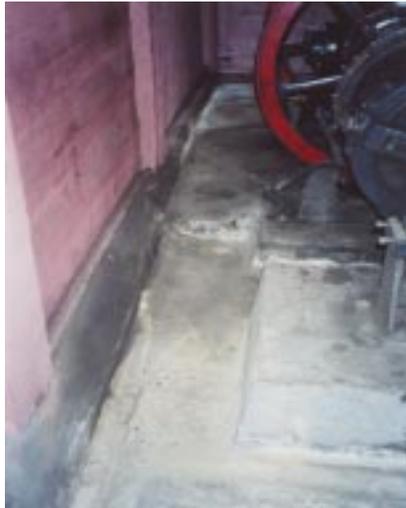
Figure 7 - Failed west bottom sill

The west side's bottom sill lost significant strength when it became saturated and started to rot. As this occurred, the load of the tippie structure and its stored coal, became too great for the four western posts on the weakened sill. As the sill began to crush, support of the tippie from the four western posts was greatly diminished. The coal pocket then began to act as a cantilever, with the center row of posts and their beam acting as a fulcrum. The 3x12 planks attached to the 8x10 timber frame members that form the sides of the coal pocket provided tremendous stiffness for the cantilever action. However, because the interior of the pocket lacked the stiffness of the sides, the resulting cantilever forces were transferred to the two east-west 10x10 beams immediately above the hoist house. The stress resulting from this cantilever action has fractured the top portion of each of these two beams below the middle of the coal pocket.

The southwest corner of the tippie has dropped 2-1/8 inches as a result of the sill crushing. It is suspected that the reason for the asymmetrical movement and distress in the structure is that the south end of the west ground sill experienced a greater intrusion of moisture and therefore weakened more and sooner than did the north end of the sill. The resulting seesaw effect has caused the northwest corner to actually rise. The coal pocket has also leaned to the west as a monolithic unit, rather than distorting. As discussed above, the structure has significant north-south lateral bracing, but virtually none in its east-west axis. As a result the structure has been much more prone to east-west deflection than north-south. Apparently a significant amount of the east-west forces are being carried by the connections to the bucket guide timbers. These timbers are now acting as vertical cantilevers, a role they were not designed to fulfill.

Option 1. Replace all of the bottom sills and partially straighten the structure.

The structure would have all of its ground sills replaced, and would be jacked back into a more plumb position. The straightening should be accomplished only by jacking the structure. Because of the uncertain condition of the connections, no attempt should be made to pull or push the structure back into plumb. The existing temporary shoring timber could possibly be used as the jacking timber during the process. Jacks would be inserted under it at each end, and at the center. The latter would necessitate the cutting of a temporary hole in the hoist house roof. The jacking process should be closely monitored by an engineer and should proceed only to the point where it is believed that the existing stresses are relieved and that no new stresses are being induced. Because of the long term creep and set of the timbers and their connections, there may be some residual tilt left after all of the sills are replaced and the base posts are raised to, or near to, their original positions. Because the lean developed relatively early in the structure's life, as a result of design flaws, it has in effect become part of the tipple's history, and should be interpreted as part of the structure's history. The interior and exterior sheathing, windows and doors of the hoist house have either deformed or been replaced since the lean developed. The jacking of the structure will necessitate, at least a partial rebuilding of these architectural elements, particularly on the south and west sides.

Option 2. Replace only the failed west sill and partially straighten the structure.

This option is basically the same as number one, but more temporary in nature. To prevent further leaning, and possible catastrophic failure, only the failed west bottom sill would be replaced. As stated in option 1, this can be done either with a new treated wood member, or with a

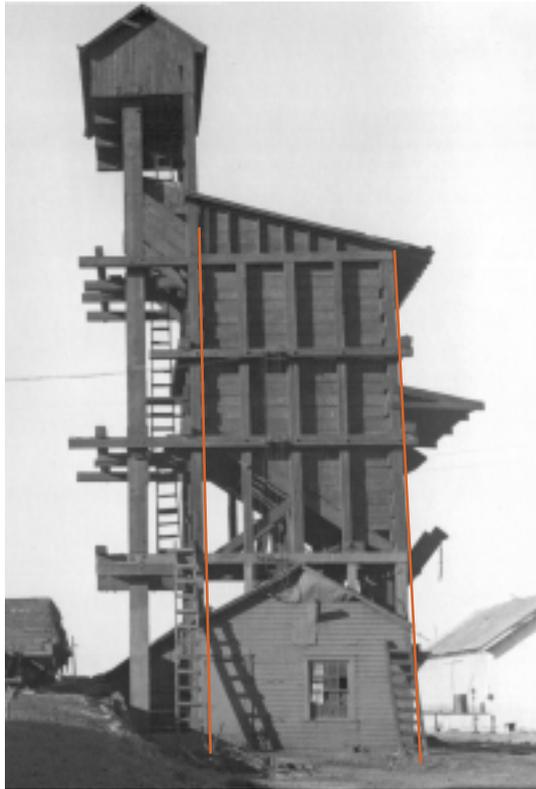
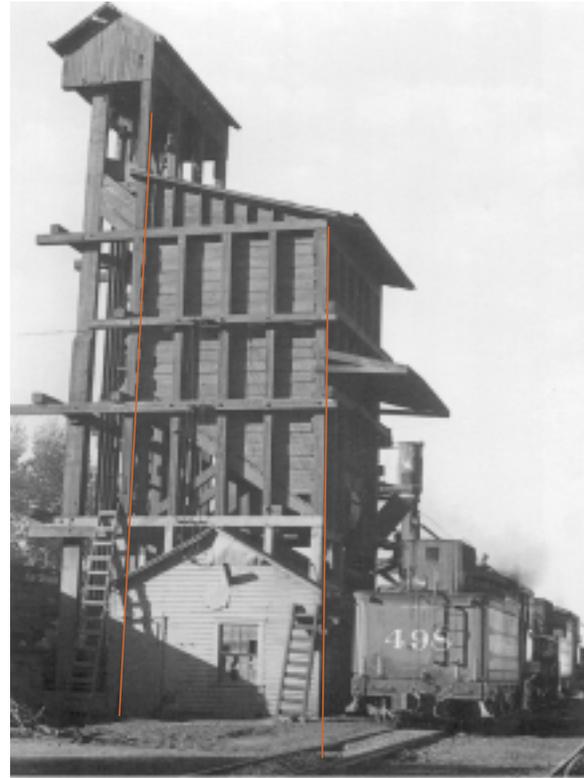
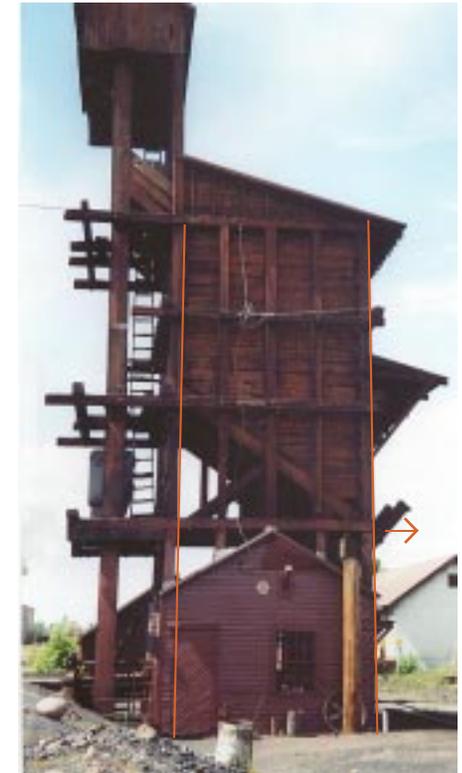
The tippie's lean appears to have occurred over an extended period of time, perhaps starting not long after its completion. There is both photographic and field evidence to suggest this hypothesis. In figure 8, taken fourteen years after its completion, the structure appears to be vertical, although it is not possible to say so with certainty. However, examination of figures 9 and 10 show that by the late 1960s the tippie had achieved a substantial part, if not all of its current lean. Red lines have been drawn on these photographs of the north side, parallel to the coal pocket timber structure. Note that the lines diverge from parallel with the lower hoist house structure at the connections above the first tier of posts. Photograph 11 taken in 2001 shows approximately the same lean in the structure.

*Figure 9 - 1966 (Dorman)*

*Figure 10 - 1967 (from "Rio Grande Narrow Gauge - The Final Years, Alamosa to Chama" by Joseph P. Hereford, Jr' and Ernest W. Robart)*

*Figure 11 - 2001*

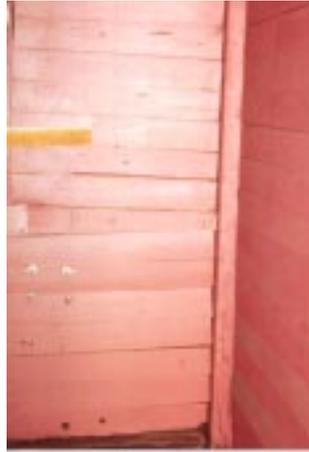
Figure 12 - Interior South West Corner

Examination of the interior of the hoist house further reveals evidence of the age of the structure's lean. There are 5-1/4" x 5/8" tongue and groove horizontal sheathing boards on the interior of the hoist house's walls that are not shown on the drawings. (Section "A-A" of the original drawings shows exposed studs.) In the southwest corner, the siding appears to have been installed after the settlement of the corner had occurred. This is evidenced by the tapered board that was installed in this corner to accommodate the settlement. (See photograph 12) While it is possible that the tapered board is a later "fix", it does not appear to be so. In either case, whether it is a fix or original, the installation of the board post-dates the settlement of the corner.

It can be concluded from these observations that the lean began in the period between the 1940s and 1960s, or is between 40 and 60 years old. The interior sheathing boards do not show signs of ongoing movement or stresses (such as nails being pulled out of their holes), nor do the exterior photographs taken over time suggest that the movement is continuing.

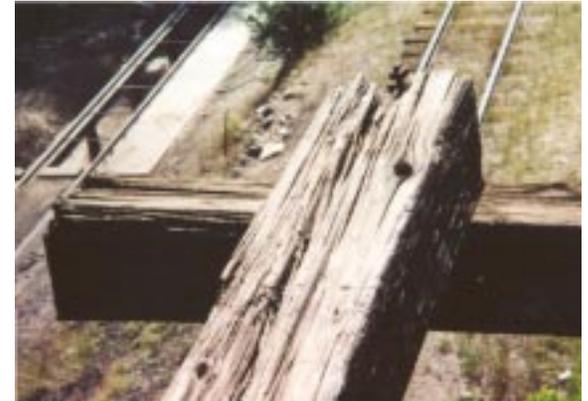
*Figure 13 - Timber Connection on East Side*

The only significantly decayed areas, other than the bottom sills, are the tops of some members, particularly the east ends of timbers that project out around the coal buckets (Figure 13). These areas should not be covered with any flashing materials. While flashing may prevent the entry of some moisture, it also poses the risk of trapping moisture which could cause considerably more harm. However, the decayed

areas can be filled with asphaltic tar to limit further decay, although they should not be completely filled.

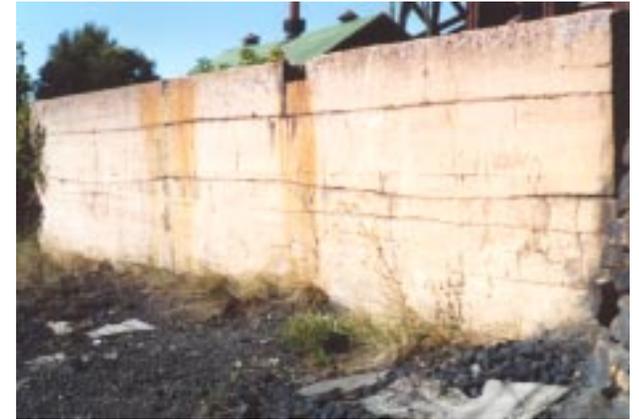
*Figure 14 - East Wall of Coal Hopper*

At the time of the inspection, the twin coal hoppers had coal covering most of their bottoms. However, the concrete structure that was visible, is very weathered with a very rough and irregular surface, but appears to be sound, other than one significant crack on its east side (See Figure 14). Even here there is no apparent movement in the structure. The weathered surface of the coal hopper is at least in part the result of the physical damage caused by coal being dumped against its surfaces. It may also be the result chemical action. Coal is an unstable mineral and subject to leaching-out many of its elements, particularly carbon, oxygen and sulphur, which may be the cause of the deterioration. Carbon dioxide for example, can react with the cement paste (lime) and cause its deterioration. Further, it was also common to use cinders and burned coal as aggregate in early concrete mixes.<sup>2</sup> These too can cause the deterioration of the cement paste. It is not known however if any of these were used in the Chama tipple. Additionally, the coal in the hopper can soak up and hold moisture. These factors, combined with the extreme freeze-thaw cycle of northern New Mexico, have no doubt produced a very severe weathering environment.

Because concrete is a porous material, it needs to breathe. When concrete is as weathered as that in the hoppers, it is inevitable that water will enter. Any attempt to seal the concrete would be only partially successful at best, and could pose a risk of causing more harm by trapping moisture. It is recommended that the hoppers be emptied to the greatest extent possible to minimize the exposure to coal and to allow the concrete to breathe. The major open cracks can be sealed with a caulking to limit the entry of water into these spaces. This could greatly limit the widening of these cracks by freeze-thaw.

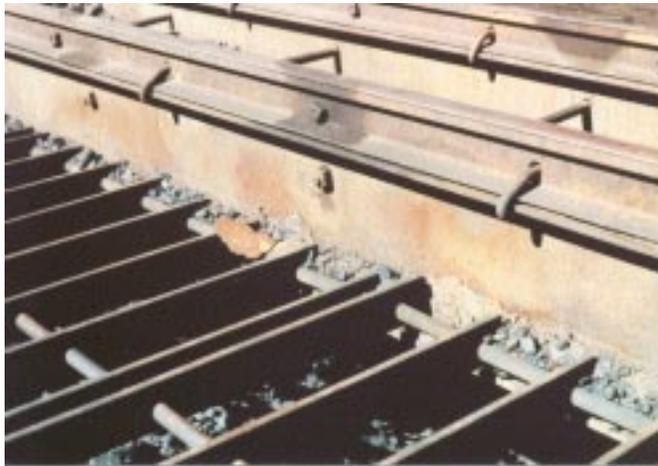
*Figure 14 - Track Support Beam*

The “I” beams supporting the coal delivery tracks are losing thickness due to rust and surface delamination (Figure 14). To prevent further deterioration, perhaps to the point of no longer being able to support cars, they should be sandblasted of all loose rust, and painted. Because they were most likely unpainted when new, they should be painted color similar to unpainted steel.

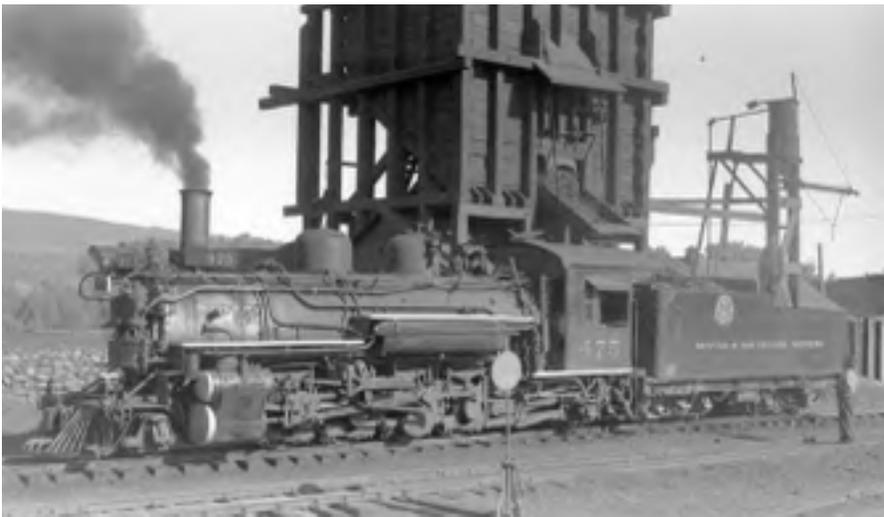
*Figure 15 - West Side in 1939 showing Equipment Shelter  
Otto Perry photo from Denver Public Library*

The equipment has a projecting roof structure to shelter it from the elements. This roof was not shown on the original drawings, and is not present in photographs dating from as late as 1939. The roof is supported at its quarter points, or approximately five feet on center by 2x8s. The only bracing for the structure are 2x6s (or 2x8s) at each end of the roof. Based on the photographic record, these members were added between 1967 and 1979. These two members are approximately 10 feet long and are dangerously bowed under their load. Because the ends of these braces are also starting to split, they are at risk of failure at their nailed connections. The shelter is sagging very significantly and may be at risk of collapsing in the near future. It poses a potential hazard to the trains and their passengers passing in front of it, as well as to visitors to the yard. The structure should be removed at this time to prevent possible injury.

Prior to the construction of the wooden roof structure, a small sheet metal canopy protected the chute mechanism, although it was not indicated on the original construction drawings (See Figure 15). Portions of this structure appear to remain in place. Because the canopy dates from early in the period of significance, and reasonable evidence of its original construction remains, it should be restored in lieu of reconstructing the later wood shelter.
