# Chama Coal Tipple Structure Report / Maintenance Plan

## Cumbres & Toltec Scenic Railroad

Prepared by Steven Kells and Jim Kreis  
for the Friends of the Cumbres & Toltec Scenic Railroad  
Winter, 2002

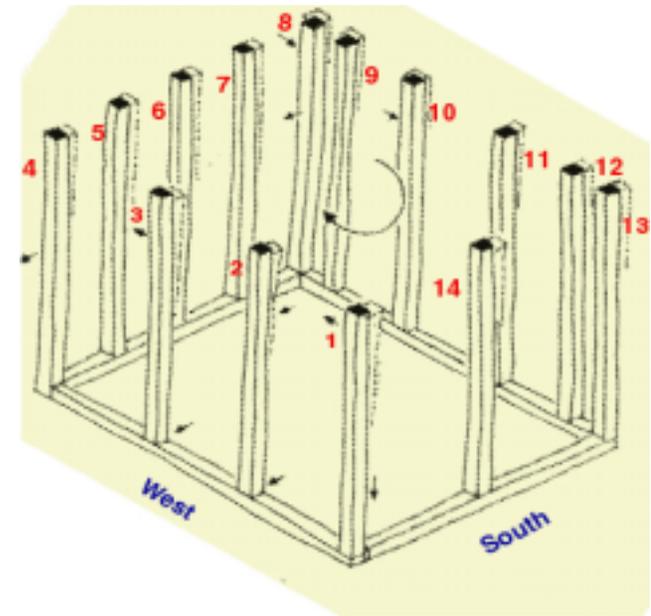
Figure 6

The tipple has a lean to the west of approximately 24 inches from the vertical measured at its highest point above grade. The lean is the result, primarily if not entirely, from the failure of the bottom (mud) sill located along the west side of the structure. At the southwest corner of the structure this member has been crushed downward 2-1/8 inches and along its length it has rotated allowing the base of the post resting on it to be deflected outward by as much as 5". All of the 14 posts that extend up through the hoist house to support the outside perimeter of the coal pocket have been stressed by this combination of downward and outward forces, resulting in the clockwise racking, or twisting of the structure as shown above.

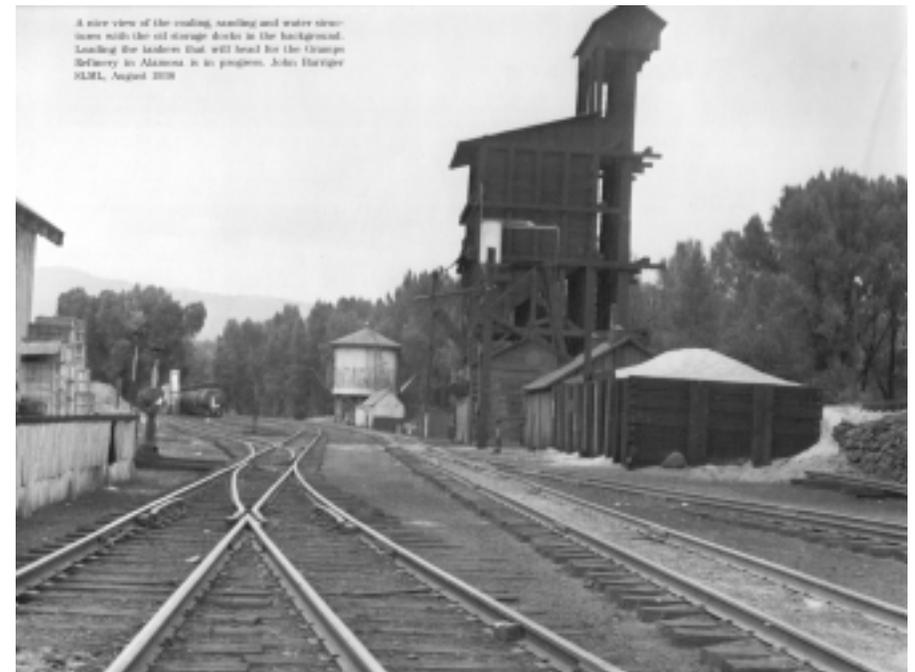
Figure 8 - Chama Yard in 1938  
(from "Chama / Cumbres with a Little Chili" by Richard Dorman)

The tippie's lean appears to have occurred over an extended period of time, perhaps starting not long after its completion. There is both photographic and field evidence to suggest this hypothesis. In figure 8, taken fourteen years after its completion, the structure appears to be vertical, although it is not possible to say so with certainty. However, examination of figures 9 and 10 show that by the late 1960s the tippie had achieved a substantial part, if not all of its current lean. Red lines have been drawn on these photographs of the north side, parallel to the coal pocket timber structure. Note that the lines diverge from parallel with the lower hoist house structure at the connections above the first tier of posts. Photograph 11 taken in 2001 shows approximately the same lean in the structure.
